Curve Theatre Remedial Works

Lindapter Hollo-Bolts provided a robust, one-sided connection solution to safely reinstate the aluminium brise soleil façade at Leicester's Curve Theatre following the failure of the original fasteners.

Location: Leicester, UK
Product: Hollo-Bolt® Countersunk by Lindapter®
Quantity: 2450
Client: Leicester City Council
Contractor: Clear Line Ltd, Sheffield

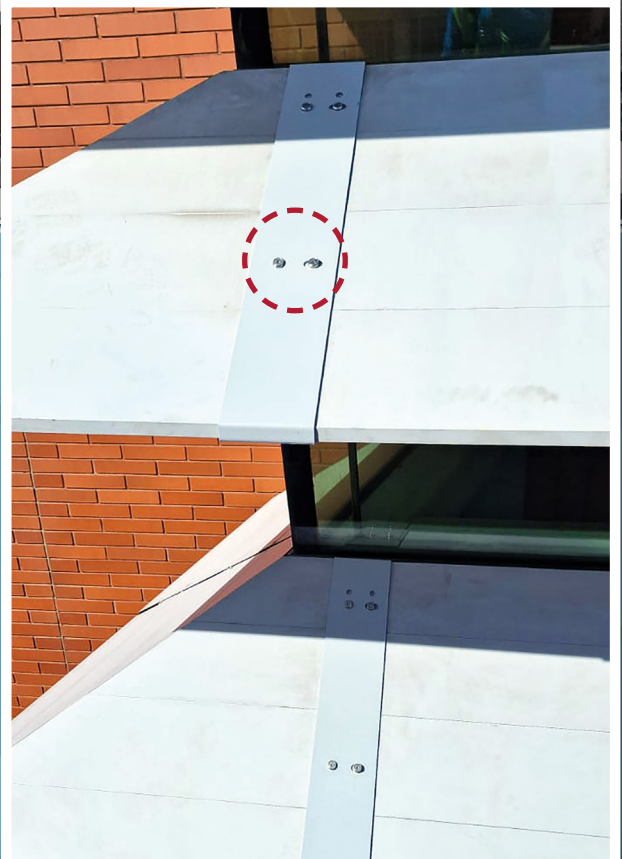
Each blade connection now contains four Hollo-Bolts per "J" strap to improve load distribution & overall system resilience

The design allowed for adjustability through the bracket system, enabling precise alignment of the blades during reinstallation. Each blade connection was enhanced by increasing the number of fasteners, with four Hollo-Bolts specified per "J" strap to improve load distribution and overall system resilience.
